## Butyl leakage into cavity

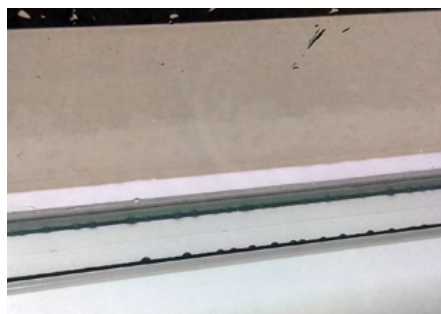
Example of butyl leakage of insulating glass units

This phenomenon may be caused by e.g.:

- high temperatures in the rebate area
- excessive contact pressure on the edge area of the glazing

Comparative testing by the Bundesverband Flachglas has shown that butyl leakage of all-edge supported IGUs of windows and façades is a purely visual characteristic

which has no impact on the durability of the installed IGU.

Butyl leakage up to a height of 3 mm does not impair the proper functioning of the IGU and therefore does not constitute any grounds for complaint (result of the BF study).

- Leakage of butyl into the IGU is less noticeable if the glass bite is increased within the permissible limits (see DIN 18545).
- Recommended minimum butyl quantity, see Table.

The quantity specified here is recommended so that the durability of the IGUs is not impaired.
